**Facilities Condition Assessment  
for  
Lauderdale Lakes  
Country Club  
Elkhorn, Wisconsin**

Re: Facilities Condition Assessment for  
**LAUDERDALE LAKES COUNTRY CLUB**  
Elkhorn, Wisconsin  
Job No. 1525

**Facilities Condition  
Assessment**

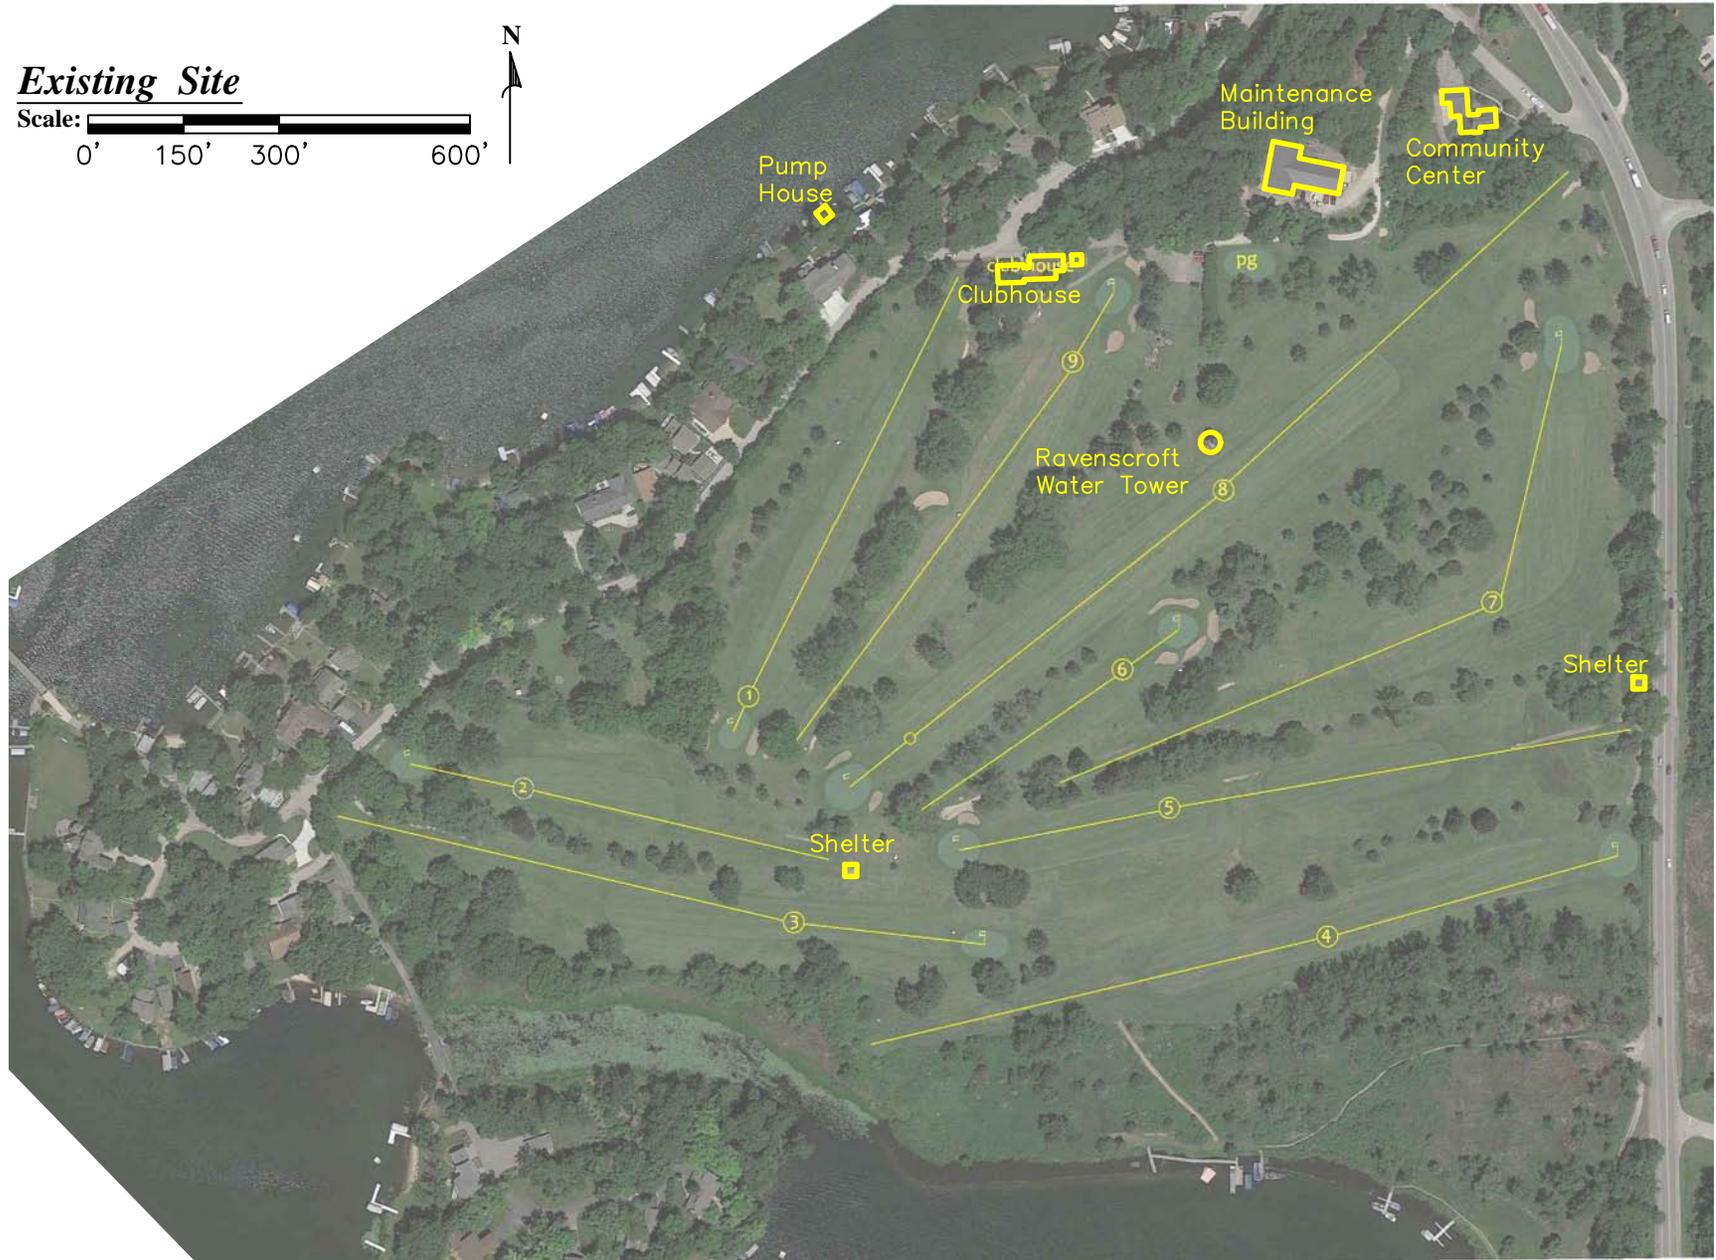
***Existing Site***

Small scale aerial photographs, maps, and a survey of the property are attached, along with a summary of the areas of the buildings and structures.

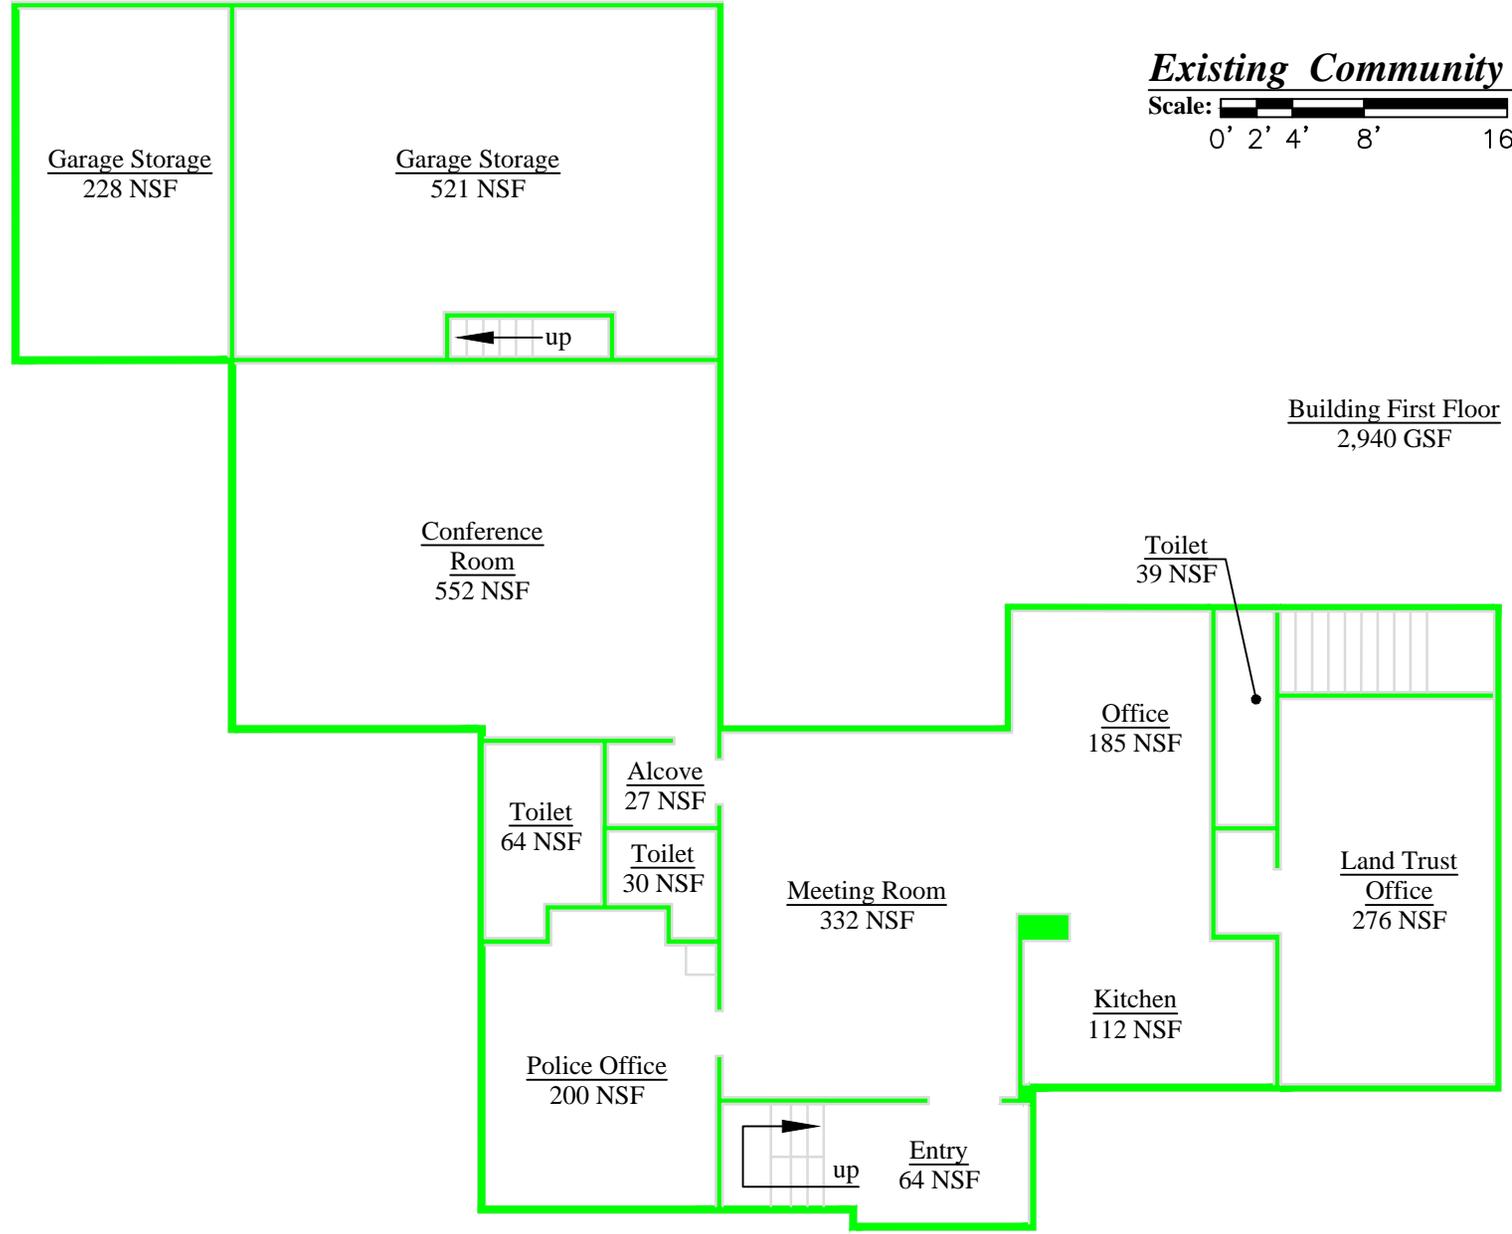
***Existing Community Center***

Building First Floor  
2,940 GSF

The Community Center is a 5,180 square foot building originally constructed as a single family residence in the 1920s. It now serves as offices for the Kettle Moraine Land Trust and the Lauderdale Lakes Water Safety Patrol, as well as offices and a meeting room for the Lauderdale Lakes Lake Management District (LLLMD). The building's interior is well maintained. The exterior is in need of repair and painting. The majority of the building consists of small rooms on non-accessible floor levels which can be used for little more than storage. The original design of a residence, with the additions built in the 1950s, hampers the efficient use of the spaces. Any renovations would need to address the lack of barrier-free design and non-code complaint wiring.
